Manhole Inspection Summary

Manhole # S110O1019MH

Location Address: **4822 PALMER AVE**

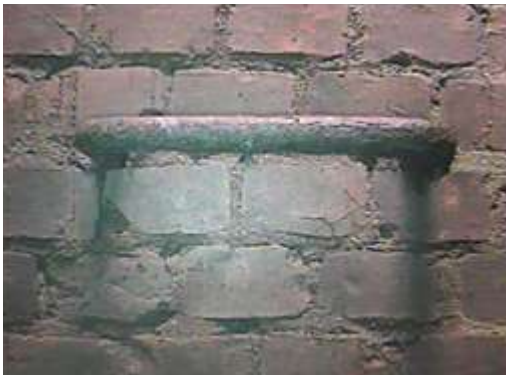
Defect 1

Steps Count: **2** Missing: **0** ☒ **Corroded**

CORRODED RUNG

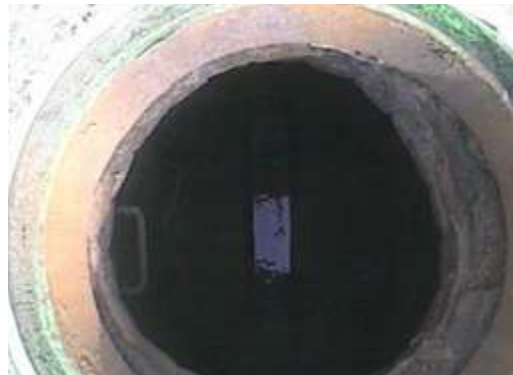
Defect 2

Frame Offset: **3** (in.) Condition: ☒ Sound ☐ Cracked ☐ Leaks

FRAME OFFSET

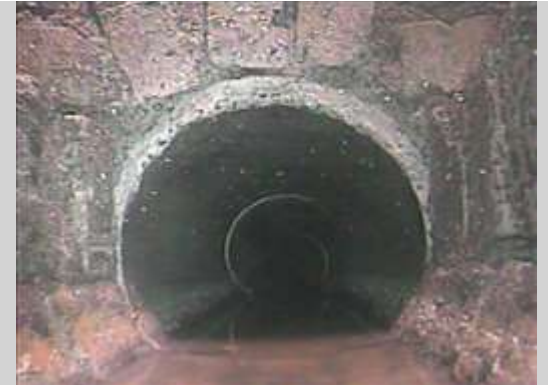
12 O'Clock Outflow

8 in. Circular Gravity Sewer
Pipe Out @ 12 O'Clock

Pipe Height: (in.) Direct
Pipe Material: **Clay** ☐ Pipe Lined
Invert Depth: **6.92** (ft.) Flow Characteristics: **Slow**
Deposits: ☒ None ☐ Mud ☐ Sludge ☐ Debris ☐ Grease
Silt Depth: (in.) Deposits Extent:
Infiltration: **None** Pipe Seal Cond: **Sound**

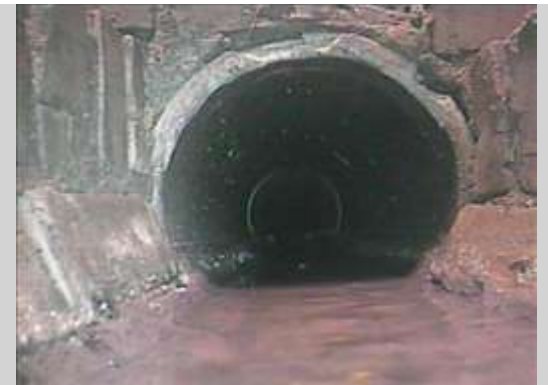
6 O'Clock Inflow

8 in. Circular Gravity Sewer
Pipe In @ 6 O'Clock

Pipe Height: (in.) Direct
Pipe Material: **Clay** ☐ Pipe Lined
Invert Depth: **6.89** (ft.) Flow Characteristics: **Slow**
Deposits: ☒ None ☐ Mud ☐ Sludge ☐ Debris ☐ Grease
Silt Depth: (in.) Deposits Extent:
Infiltration: **None** Pipe Seal Cond: **Cracked**
